# Safety Memo - Warning Labels

## Cable Shroud

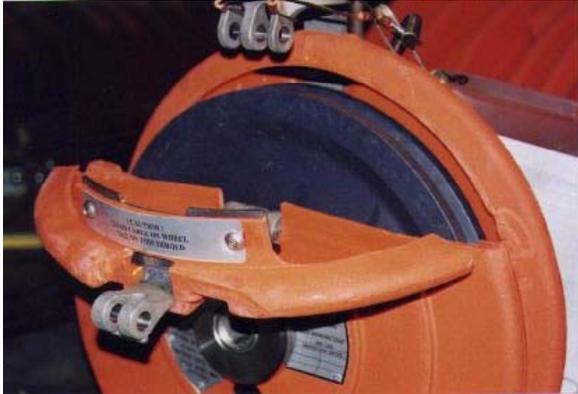
Fig. 1 Shroud Warning Label

The gate on a “shrouded” rigging sheave has a curved metal plate attached to the loading gate. This shroud comes down onto the wheel when the gate is closed to contain the cable in the groove of the wheel. It is very important to make sure the cable is actually placed in the groove of the wheel and never on top of the shroud. Wireline Technologies Inc. now has a tag available to warn operators about this hazard. A photo of this tag can be seen in figures 1 and 2.

Most of the sheaves have the handle warning tag, but only the newest sheaves will have the other tags. Please call your local Bowen Tools representative to order these tags for your sheaves. Note, sheaves sent in for recertification or repairs will automatically have these tags added.

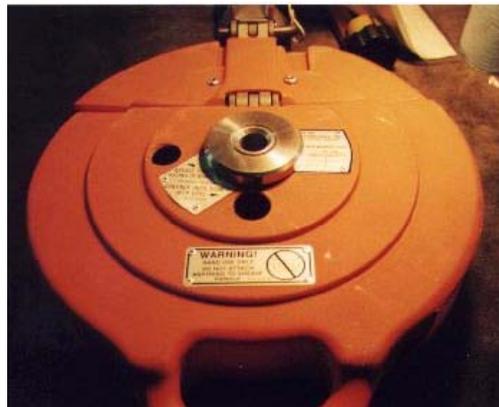
Fig. 3 Tags on Front

The front of the rigging sheaves now have three tags related to safe operation. See figure 3. The bottom tag warns against attaching anything to the handle. The handle is for carrying the sheave only. If the sheave needs to be tied back, a rig-up yoke is available for that purpose.

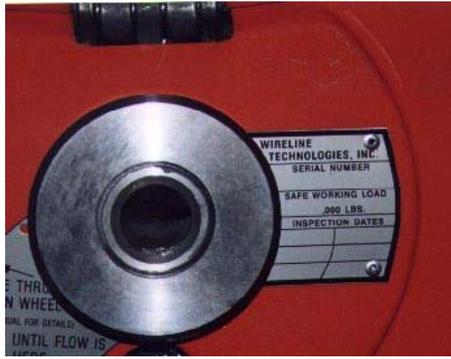
Fig. 4 Inspection Tag

The second tag (on the right side) concerns annual recertification. Most well servicing companies are required to perform annual recertifications to their rigging sheaves. WTI is now attaching a recertification tag to the sheaves. See figure 4. This tag is to be stamped with the sheaves serial number and safe working load. Then, as annual inspections are performed, the open spaces under “Inspection Dates” can be filled in with the corresponding dates. For details on recertification please contact the engineering department of your company or for WTI’s recommendation, refer to document #WTI-20.

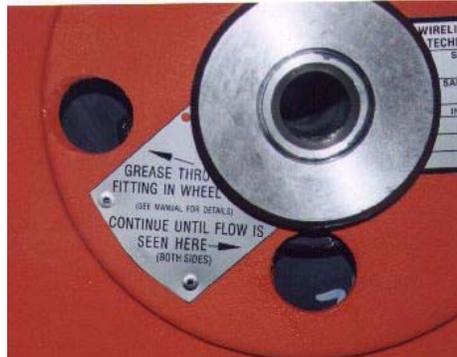
Fig. 5 Grease Tag

The third tag concerns re-greasing of the sheaves. See figure 5. Dependent upon frequency of use and environmental conditions, sheaves should be re-greased about once a month to insure lubrication and purge any moisture or contaminants. This tag shows where the grease fitting is located and explains the other holes in the cover as observation holes (one is located on the back side). When the sheave is re-greased, the old grease should be forced out of each side of the bearings to ensure each of the bearings is filled with fresh grease. The old grease can be sampled and examined, via these holes, for contaminants such as rust, metal filings, or other indicators of future bearing problems.

Note: the tag shown is on a 14" sheave, the tags for a 17" or 26" sheave are slightly different and are attached directly opposite the inspection tag.
