Safety Memo - Gate Stop

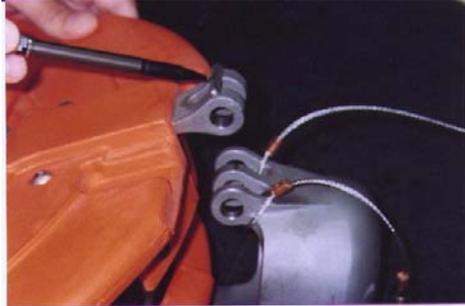
Wireline Technologies has added a stop bar to the castings of the loading gates. See figures 1 and 2. The bar is designed to prevent the gate from being closed too far and prevents loading with the gate pin installed incorrectly. See figure 3.

Fig. 1 Gate Stop

Sheaves produced before this change was made can be retrofitted with a stop bar welded onto the loading gate. Please do one of the following to ensure that this hazardous situation can not occur with your rigging sheaves. Note, sheaves sent to WTI for recertification or repairs will automatically have this modification performed.

- a. Return the sheaves to WTI for a free modification.
- b. Call WTI to have some stop bars sent to you free of charge and have the modification done at your location by a qualified welder.

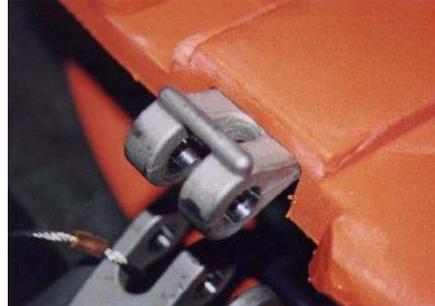
Fig. 2 Gate Stop Close Up

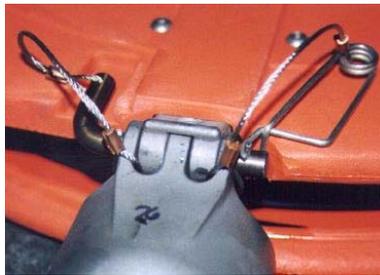
Fig. 3 Gate Closed

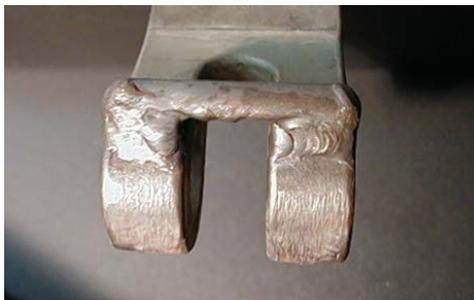
1. There is no need to disassemble the sheave. The welding can be done with the gate in place.
2. Clean the exposed end of the loading gate removing any dirt or grease.
3. Clamp the stop bar to the loading gate with the slot facing the gate and centered with it.
4. Using a TIG welder weld the gate stop to the loading gate with a seam weld all the way around on each end. We recommend the following parameters: DC- /60 amps/11volts. A close up of a finished weld can be seen in figure 4.

Fig. 4 Gate Stop Welded
